Original Article

# Thermal Degradation and Residual Strength Assessment of Reinforced Concrete Members Exposed to Elevated Temperatures

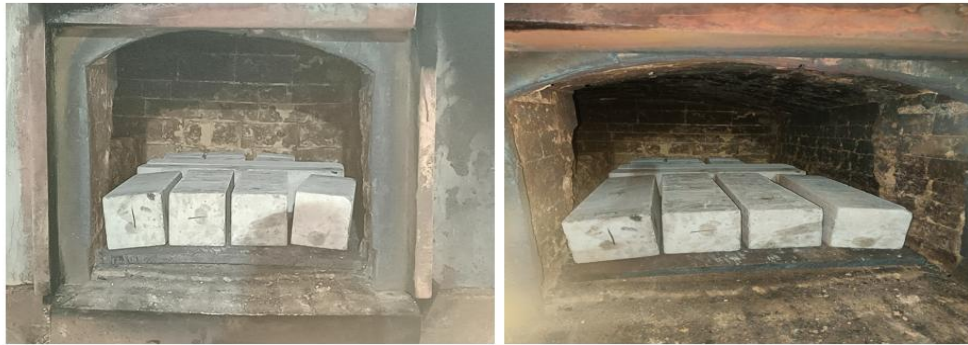
Fig. 1 Placement of casted cubes and beams in diesel furnace

After curing, specimens were subjected to elevated temperatures in an electric Diesel furnace with internal dimensions sufficient to accommodate either three cubes or one beam per heating run (the beams were heated individually due to their size). To ensure uniform heating, specimens were placed such that all faces were exposed (for cubes) or all sides of the beam were heated (the beam was on supports in the furnace, allowing roughly uniform heating around its perimeter) as shown in Figure 1. The furnace temperature was controlled via a programmable logic controller to follow the desired heating profile.

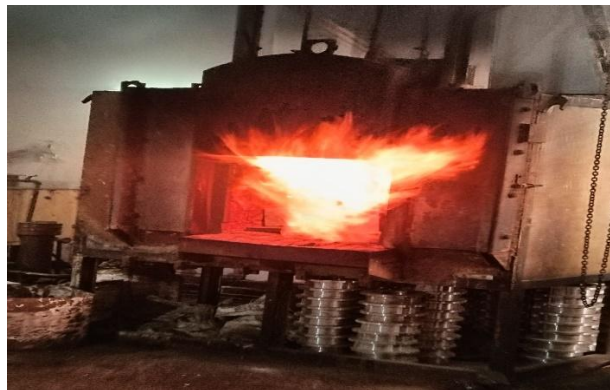
Fig. 2 Specimen exposed to fire in an electric diesel furnace

Target peak temperatures were selected as 200 °C, 400 °C, 600 °C, 800 °C, and 1000 °C, representing a range from mild to extreme thermal exposure as shown in Figure 2. In each test, the furnace was ramped at approximately 5-10 °C per minute up to the target temperature. When the intended temperature was achieved, it was kept steady for 2 hours. This allowed the concrete in the middle to get close to the same temperature as the furnace and mimic a long-lasting fire.

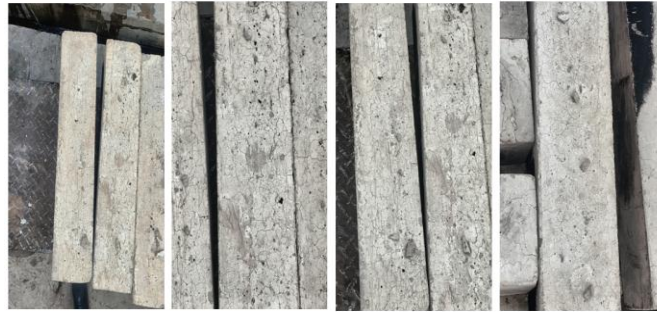
Fig. 3 Specimen after fire exposure at different temperatures (visible cracks)

Minor surface cracking and color changes were noted: specimens turned reddish-pink around 300 °C (due to hematite formation from iron compounds) and gray/whitish at 600-800 °C (due to dehydration of cement paste), as shown in Figure 3. By 1000 °C, cube corners had rounded slightly, and surfaces showed micro-cracks, but overall geometry remained intact.

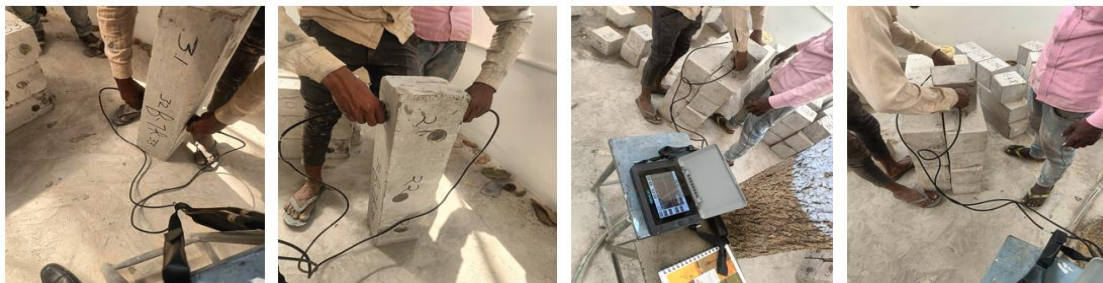
Fig. 4 Ultrasonic Pulse Velocity (UPV) testing of specimen

Once cooled, the samples were again tested for sound speed to identify any damage inside (as shown in Figure 4). For the cubes, the sound pulse travelled directly from one face to the other (150mm apart), and the time it took to do so was recorded.

For beams, UPV was measured in two orientations: (1) across the cross-section (150 mm path length, transmitter and receiver on opposite faces of the beam's mid-span cross-section) to gauge local damage in the concrete cover, and (2) along the length (transmitter at one end of the beam, receiver at the other end, 700 mm path) to see if a pulse could travel through the entire span.
